# Assessment of Emergency Exit Pathways and Fire Safety Measures in One of Football Stadium in Greater Malang: An Examination Following Indonesian Guidelines

Affan Al Maududi, Erianto Fanani\*, Marji, Djoko Kustono

Universitas Negeri Malang, Jl. Semarang No. 5, Malang, Jawa Timur, 65114, Indonesia

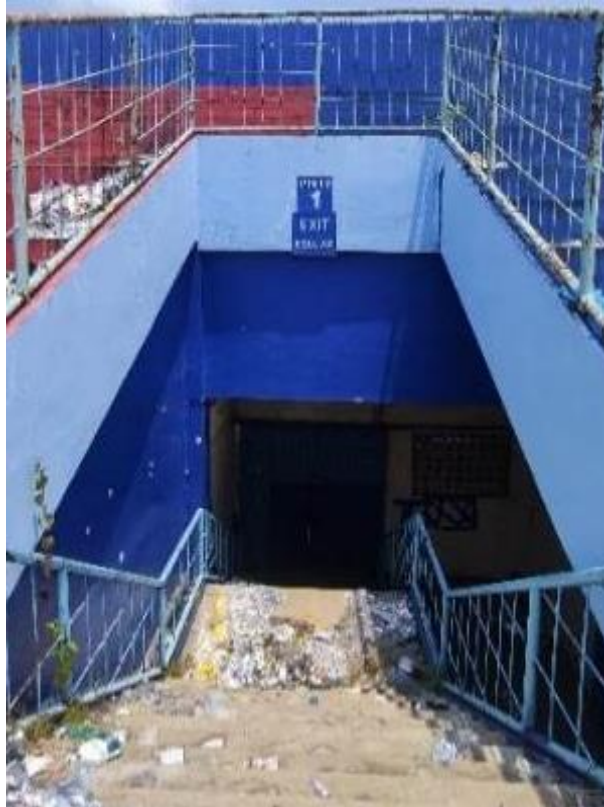
**Figure 1. Emergency Stair Gate 1**

The emergency stairs observed and measured for compliance are those used for the entry and exit of spectators at gates 1 through 14, and the VIP stand. The stairs for gates 1-14 run straight from the exterior of the stadium to the center of the stand. The stairs are made of relatively fire-resistant concrete without any finishing on the floors. In contrast, the stairs in the VIP stand have ceramic finishing on the floors. Between the stairs, thick walls act as fire barriers. Measurements of the stairs at gates 1-14 and the VIP stand revealed a width of 180 cm for the VIP stand stairs and 231-238 cm for those at gates 1-14. The tread depth was found to be 28-30 cm, and the tread height ranged from 18.5 to 20 cm. All stairs had handrails, the height of which varied between 80 and 114 cm. The stair corridors had lights powered by electricity near the entrance.

The checklist results for the compliance of the emergency stairs with SNI 03-1746-2000 and Permen PU No. 26/PRT/M/2008 at gates 1-14, and the VIP stand showed a compliance rate of 81.47%. This indicates that the emergency stairs at Football Stadium X have a good level of compliance. Non-compliance was found at gates 6-14, which had handrail heights exceeding 96 cm above the stair surface and the VIP stand, which had handrail heights below 86 cm. There was also non-compliance in all observed areas concerning emergency lighting because the lights installed were powered by electricity and not emergency lights (Kementerian Pekerjaan Umum dan Perumahan Rakyat, 2008).

Even though the compliance level of the emergency stairs can be considered good, there is still room for improvements. Recommendations include adjusting the height of handrails on the stairs to between 86 cm and 96 cm and installing emergency lighting inside and in front of each emergency staircase to facilitate direction towards the stairs.

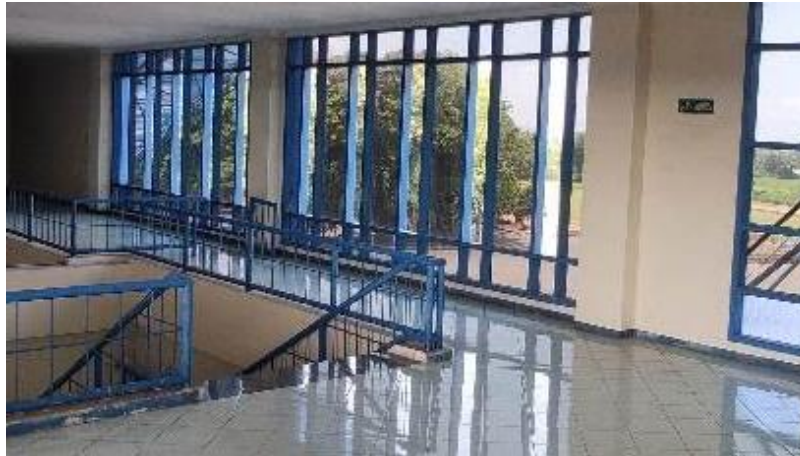
**Figure 2. Egress Facility VIP Stands**

The egress facilities observed and assessed are the entry and exit paths at gates 1-14, VIP stands, the Changing Room, Medical Room, and the Press Conference Room. In this stadium, the entrance and exit paths are identical and not separated. There are no specialized routes intended for emergency evacuations such as during a riot, fire, or natural disaster. The egress facilities at gates 1-14 comprise the passageways from the stairs leading into and out of the stadium, with heights exceeding 2.5 meters and 243-250 cm at protrusions. Evacuation route signs are absent around gates 1-14; only EXIT labels are displayed above all gate corridors from one to fourteen, excluding gates five and six. However, for the VIP stands, Changing Room, Medical Room, and Press Conference Room, evacuation route signs are installed at intervals of more than 12 meters each, leading to the exterior of the stadium building. The egress facilities are devoid of obstacles or impediments that could hinder visitors from exiting the stadium building.

The compliance checklist for the exit routes with SNI 03-6574-2001 at gates 1-14, VIP stands, player's Changing Room, Medical Room, and Press Conference Room resulted in a score of 68.8%, signifying that the egress facilities at Stadium X have a satisfactory level of compliance. Non-compliance was identified at gates 1-14 due to the absence of proper and accessible directional signage guiding spectators to exit routes; only exit signs were present above the corridors at all gates and VIP stands, except gates 5 and 6.

Improvement suggestions for the egress facilities based on SNI 03-1746-2001 include adding evacuation route signs at gates 1-14 and VIP stands. At least every 12 meters, there should be an evacuation route sign to assist visitors in locating evacuation routes. There is a need to redesign the entrance and exit routes to make them separate, and to establish evacuation routes that can enable the evacuation of all spectators in line with standard emergency evacuation timelines.

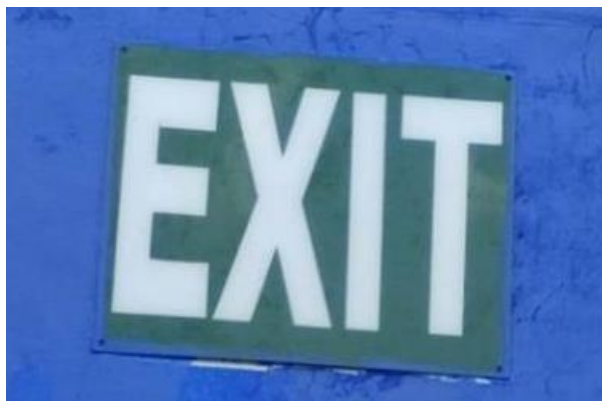
**Figure 3. Exit Sign**

The safety signage affixed to this stadium building includes: evacuation route signs located at the VIP stands, medical room, players' changing room and press conference room, and exit signs at gates 1-14 excluding gates 5 and 6. During the observation, the researcher did not find exit signs at gate 5 and gate 6. The size of the directional and exit signs meets the required standards, i.e., they have a minimum letter height of 15 cm and a minimum letter width of 2 cm. The directional and exit signs in this stadium have not been adequately illuminated, meaning there is no light on these signs.

The compliance checklist results for Safety Signage with SNI 03-6574-2001 at gates 1-14, VIP stands, players' changing room, medical room, and press conference room are 53.32%, indicating that the safety signage at Football Stadium X has a low level of compliance. The non-compliance found includes the absence of exit signs at gate 5 and gate 6, and no evacuation

route directional signs found at the exit facilities at gates 1-14. All exit signs do not appear to have adequate lighting from either an external or internal source.

Suggestions for improving safety signage based on SNI 03-6574-2001 include installing the required size exit signs at gate 5 and gate 6. There should also be additional directional signs towards the exits at all gates 1-14 and VIP stands. Directional signs can be placed on the floor surface leading to the exit. Each directional sign needs to be provided with adequate lighting, either from an external or internal source. As mentioned in Permenpora No. 7 of 2021, there should be safety signage indicating regulations before entering the stadium.

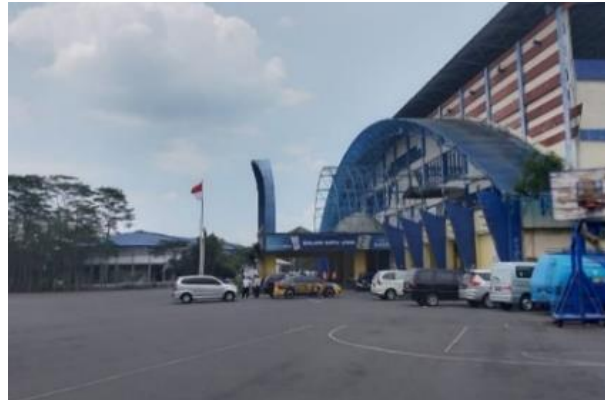
**Figure 4. Area Outside The Stadium Structure as a Assembly Point**

The assembly point at this stadium building is an area outside the stadium structure. The stadium spans a total area of approximately 3.5 hectares, comprising a 2,664 m<sup>2</sup> building, a 2,223 m<sup>2</sup> western VIP stand, northern, eastern, and southern economy stands with an area of 10,700 m<sup>2</sup>, and a supporting area of 4,028 m<sup>2</sup>. The open area around the stadium, approximately 1.5 hectares, can serve as a safe point and accommodate an overflow of spectators at the start and end of a match, as well as in emergency situations. However, there are currently no assembly point signs in the stadium's outdoor yard, indicating a designated gathering area; hence, the building's surrounding space is utilized as a parking area.

The assembly point compliance checklist based on the Indonesian Ministry of Public Works and Housing Regulation Number 14/PRT/2017 has a compliance rate of 60%, meaning that the exit point at X Soccer Stadium has a satisfactory compliance level. The non-compliance is due to the absence of assembly point signs in the open area outside the stadium building. The assembly point signs should have a green background and white letters.

Improvement suggestions for the assembly point based on the Indonesian Ministry of Public Works and Housing Regulation No. 14/PRT/2017 include the need to install assembly point signs with a green background and white letters, to be placed in an obstacle-free open area at least 20 meters away from the stadium building. Planning for the flow of spectators leaving and moving away from the stadium is needed to avoid collision or overlap.

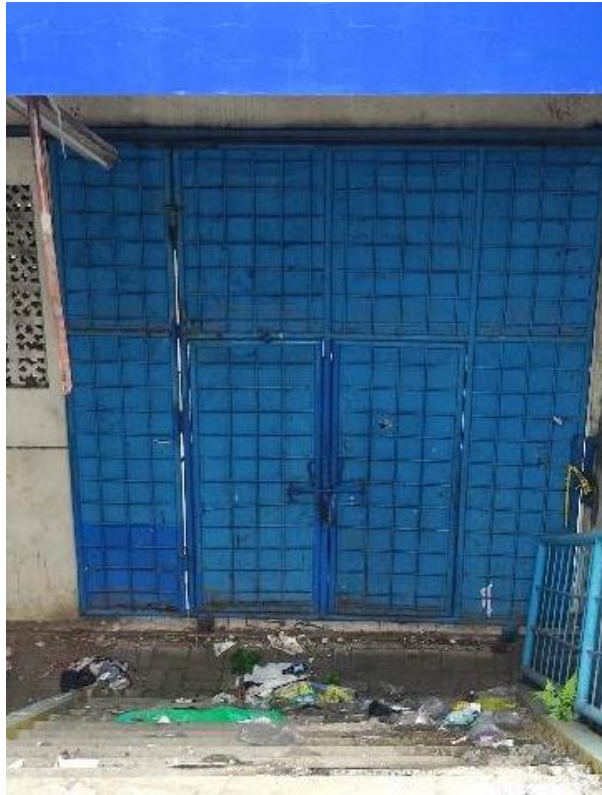
**Figure 5. Entrance and Exit Gate 12**

Emergency exits that were observed and evaluated for compliance include the entrances and exits from gates 1-14, the VIP stands, the medical room, the changing room, and the press conference room. The exit doors from the VIP stands, medical room, changing room, and press conference room utilize a folding gate located in the main stadium building. There are 5 folding gates in the main building that could serve as exit points from the VIP stands, medical room, changing room, and press conference room. Exit signs are present above these folding gates, albeit without advisory wording. Meanwhile, gates 1-14 employ large door panels, each 270 cm wide and 285 cm high, designed to be opened by sliding, with two swing-out door leaves in the middle, each door leaf being 75 cm wide and 180 cm high. These doors are equipped with manual bolt locks locked by padlocks. The threshold at gates 1-14 varies between 8-17 cm in height.

The checklist results for emergency door compliance with SNI 03-1746-2000 at gates 1-14, and VIP stands showed a compliance rate of 49.2%, indicating that the exit doors at X Football Stadium have a low level of compliance. The requirement for emergency doors that has not met the standard is the gate 1-14 door with door leaves width of 75 cm. The standard door leaf size is 80 cm with full opening, which allows visitors to exit easily. In emergencies, sliding doors with a width of 270 cm and height of 285 cm can be opened, enabling an effective number of spectators to exit. However, there needs to be personnel to open it, as sliding door requirements must be capable of being opened with a force not exceeding 133 N. Additionally, the threshold also exceeds the standard size of 12 mm. The stadium's thresholds range between 8-17 cm in height, a threshold that is too high could cause visitors to trip or fall. All doors in this stadium are not equipped with automatic door closers. At gates 1-14, doors use manual bolts locked with padlocks. In emergency conditions, padlock keys are difficult to open as they require a key. This does not comply with SNI 03-1746-2000 point 5.1.5.1. stating that locks do not need to use any specific equipment or skills or heavy effort to open them from inside the building. Whereas the exit doors in the VIP stands, medical room, changing room, and press conference room use folding gates or sliding doors, but do not yet have warning signs.

Improvement suggestions for emergency doors based on SNI 03-1746-2000 are that there should not be a threshold protruding more than 12 mm. As per SNI 03-1746-2000 point 5.1.3, if the threshold cannot be eliminated, then the floor needs to be sloped at no more than 1 : 2. The addition of automatic door closers is required on each door and improvements to the bolts and locks with devices that are easy to operate under all lighting conditions. Warning signs should be installed on or near the door in accordance with the locking and door closing system. On folding gates, there should be the writing, "THIS DOOR REMAINS OPEN WHEN THE BUILDING IS OCCUPIED".
